# TEST REPORT

Report Number: 80260300074001

| EUT Name | Solar Irradiation Sensor |
| Model Number | MBMet-500EB |

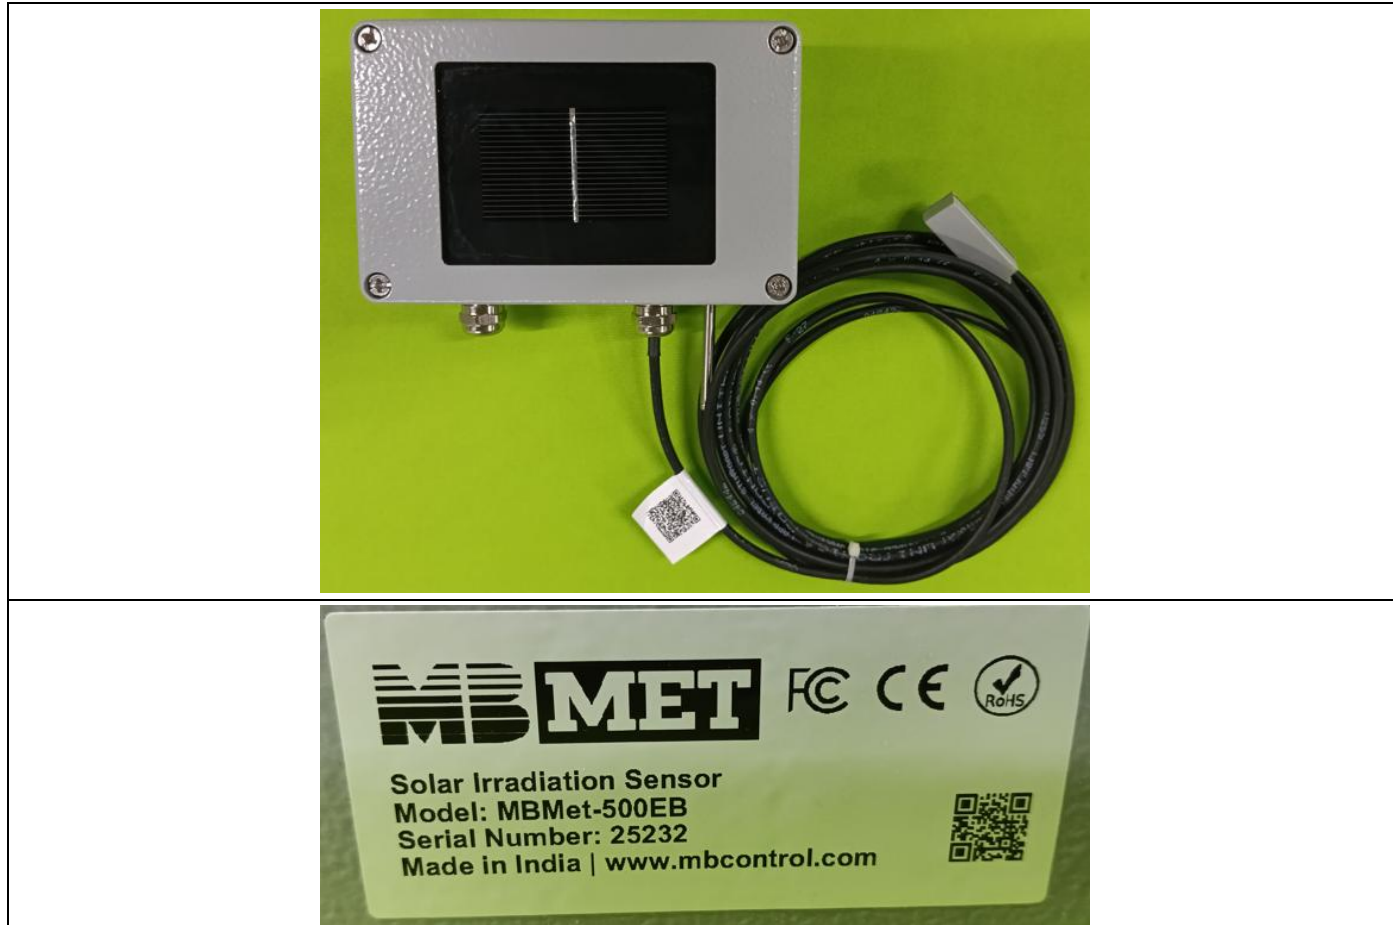
Figure 1: Equipment Photos / Images

| EUT Dimensions | 120 (L) x 76 (W) x 65 (H) mm |

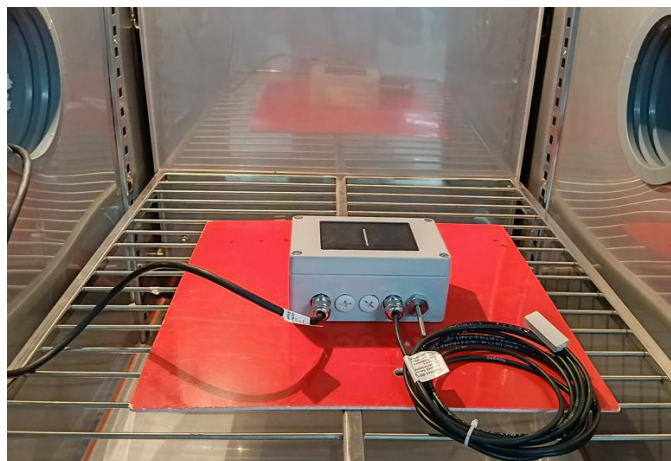
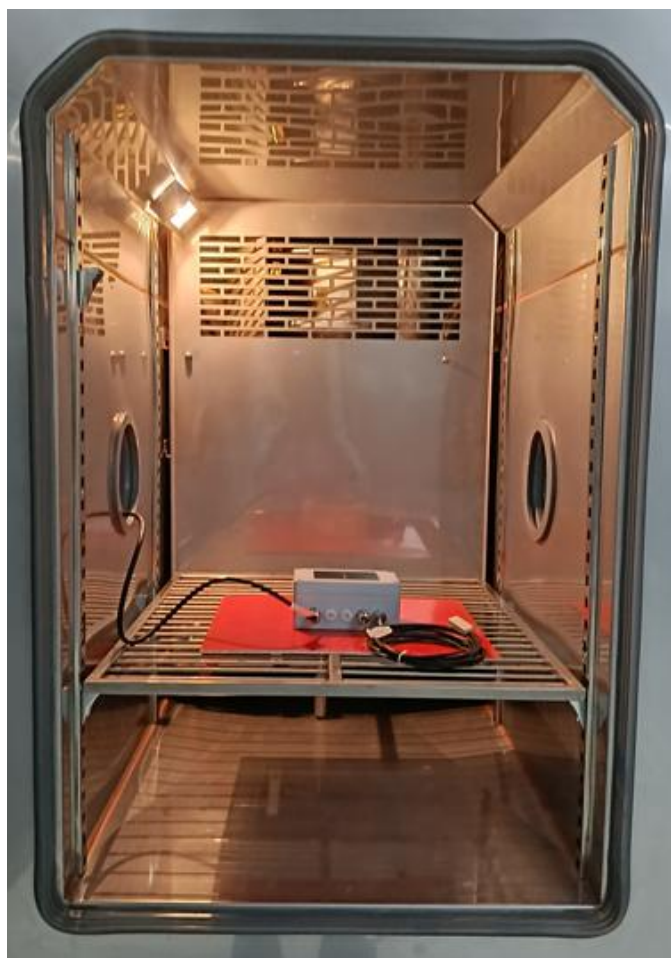
Figure 2: Cold Test Setup Photo

- The climatic chamber switched ON and verified the working conditions before starting the test.
- The test profile was created as per the specifications given.
- Test sample was placed inside the test chamber.
- The test was executed with automatic operation, and the test plot was generated at the end of the test.
- After completion of the test as per the profile, verified the chamber conditions and switched OFF

| Equipment ID | Name of the Equipment | Make / Model Number | Serial Number | Calibration Due Date |
|---|---|---|---|---|
| TSA/CAMP/ENE/ENV/EQ/23/010 | Climatic Chamber | PAC-225-B-3K | 121148 | 15-12-2026 |

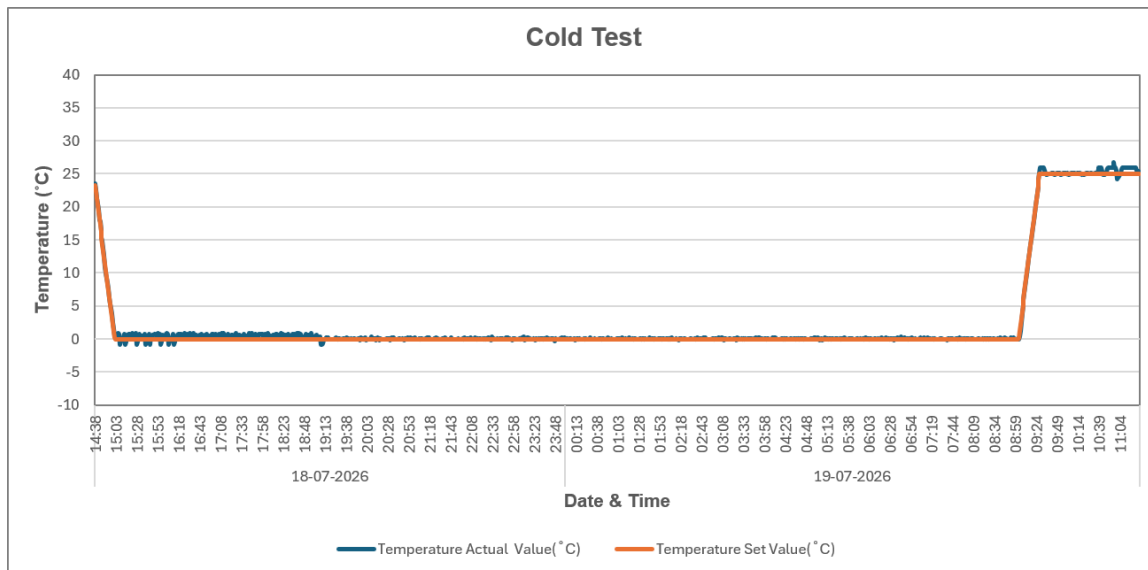
Figure 3: Cold Test Graph

| Parameter | Requirements |
|---|---|
| Temperature | 0°C |
| Duration | 16 Hours |
| Ramp Rate | 1°C /minute |
| Recovery | 2 Hour |

- NO physical damages were observed before and after completion of the test on the test samples.
- The equipment powered ON through testing, NO errors were observed during the testing.
